Pixel Module Presentations

Lawrence Berkeley National Laboratory

December 1999

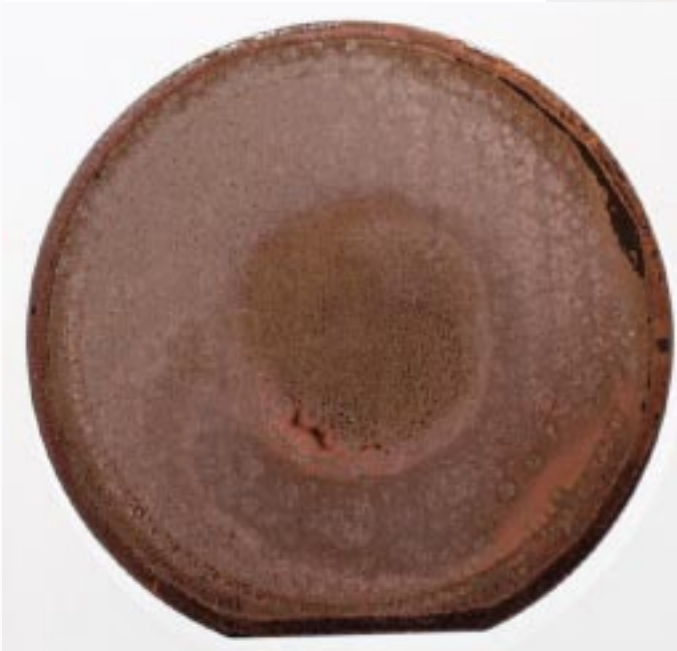
200 micron. Cracked by me.
Notice patch of interaction with
UV tape

250 micron. Large
region of interaction
with UV releasing
tape.

Dummy bumped wafers
IZM photoresist coating to
protect wafers. Did not
work well.
